Manhole Inspection Summary

Manhole # S05SS1021MH

Insp Date: **10/2/06 10:34 AM**

Location Address: **3401 INGLESIDE AVE**

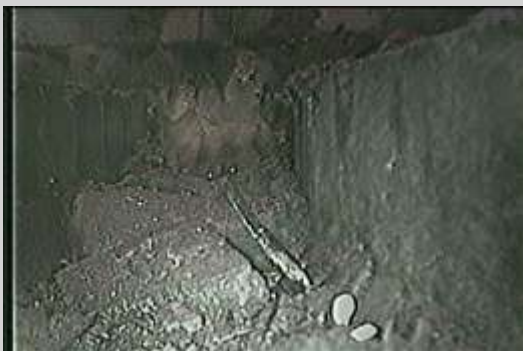
Pipe In @ 9 O'Clock

Invert Depth: (ft.) Flow Characteristics: **None**

Infiltration: **None** Pipe Seal Cond: **Unknown**
